# ***EPOXY PAVEMENT MARKING SYSTEM***

IOWA HIGHWAY RESEARCH BOARD  
FINAL REPORT HR-180

EVALUATION OF AN  
EPOXY PAVEMENT MARKING SYSTEM

FINAL REPORT  
IOWA HIGHWAY RESEARCH BOARD  
PROJECT HR-180

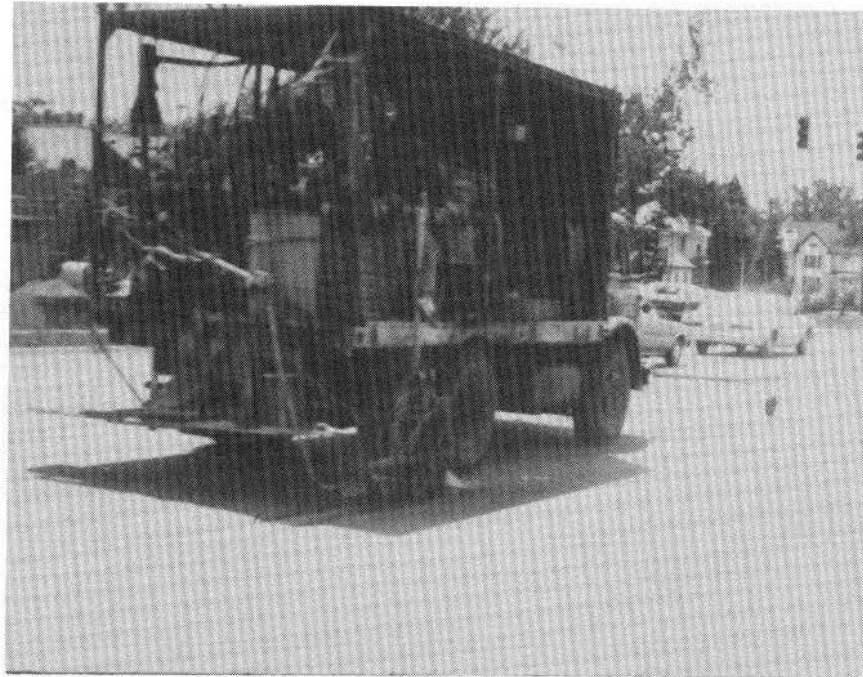
The epoxy paint was applied by equipment mounted on a standard truck body (Figure 2). Again the operation was carried out at night and DOT maintenance personnel provided traffic control.

During the painting of the lane line from the University Avenue entrance ramp to the Des Moines River bridge near Second Avenue, the material solidified in the gun and a hose, consequently only one component was delivered to the pavement. The portion of the line from the East Fifteenth Street overpass to the river bridge immediately turned black. The black material did not harden immediately and was tracked over the pavement surface by traffic.

Figure 2: Truck and equipment for  
applying epoxy paint lines

The H. B. Fuller Company representative said that several days would be required to remove the material from the gun and to rebuild the equipment, therefore, no more epoxy paint was applied. The remaining areas intended to be painted with epoxy paint were painted by the Iowa DOT with standard traffic paint.
